Inspection Report

Minerals Regulatory Program

Mine Name: Tony M
Operator Name: Denison Mines

Permit number: M0170049

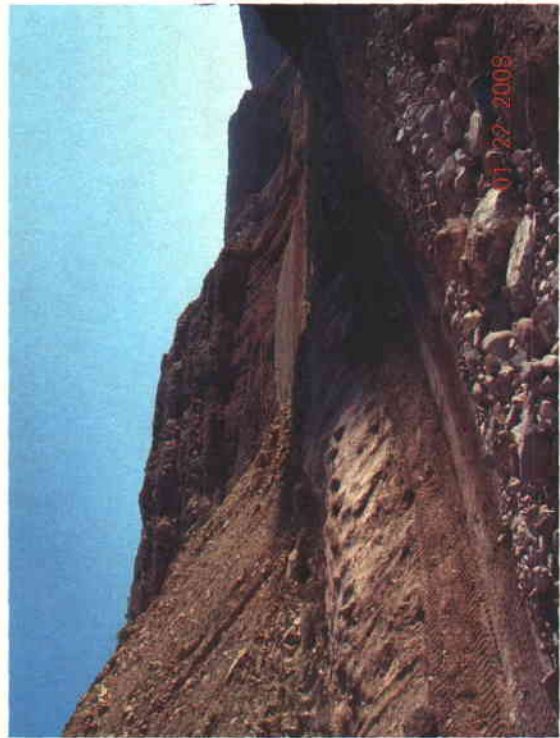
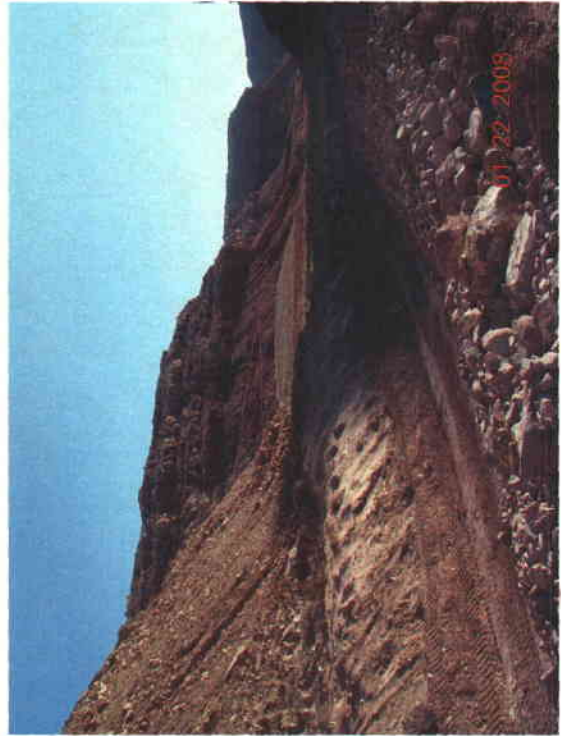
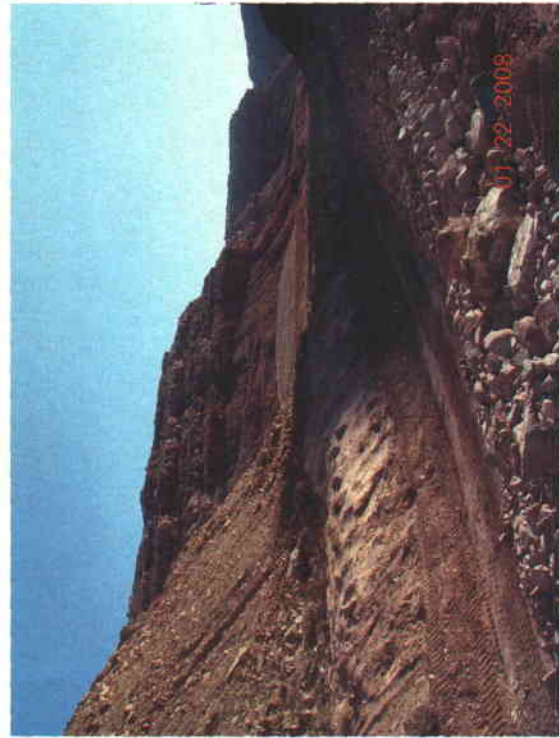
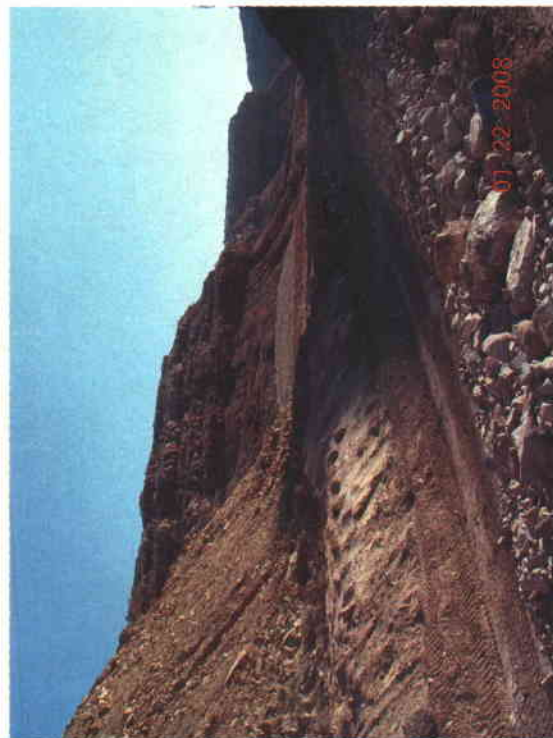
The operator has completed construction of the main channel through the site and to the north. Runoff from a series of major storms in the fall of 2006 washed away at least two or three road crossings, and the operator reconstructed one of these to restore the county road to its original position on the east side of the channel to the north of the mine. The operator also gathered and cut up the remains of the culverts so they could be recycled. The previous operator had buried a septic system drain field and building foundations, and these were exposed in the flood. Denison cleaned up this debris. For all this work, the operator will be receiving an Earth Day Award from the Board of Oil, Gas and Mining.

Photo 2. The main channel.

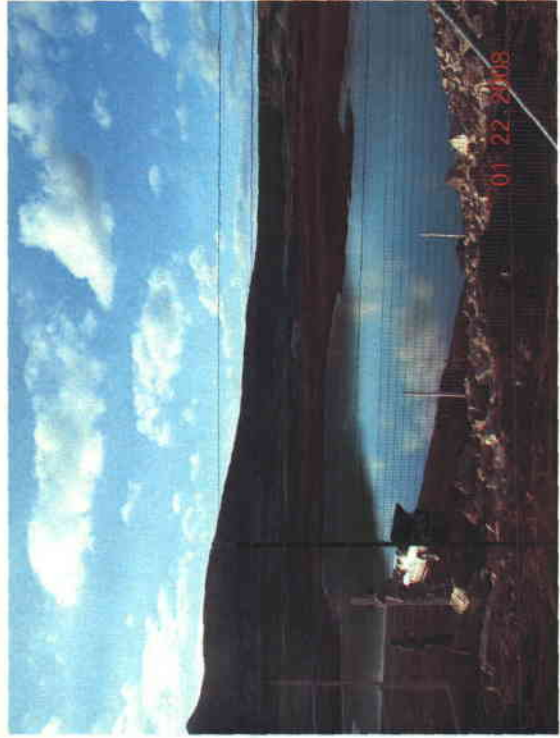
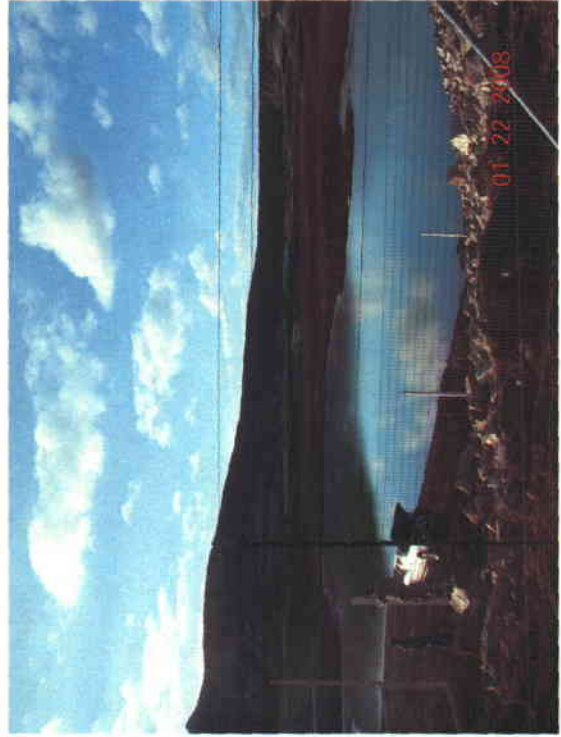
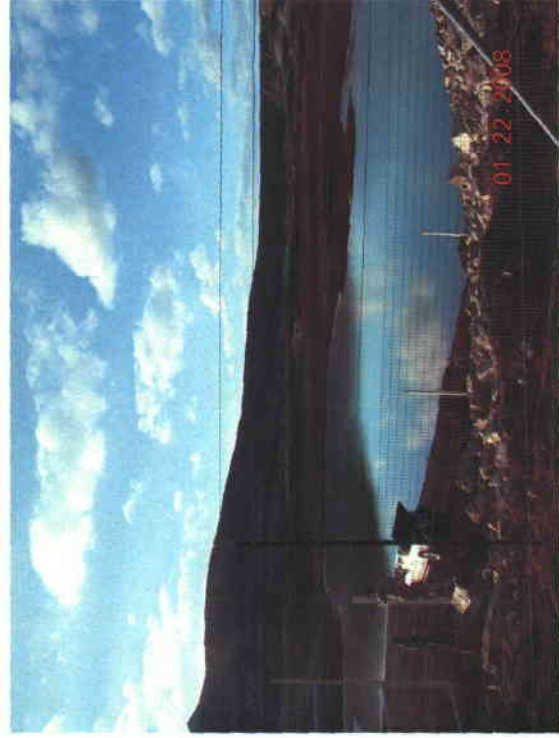
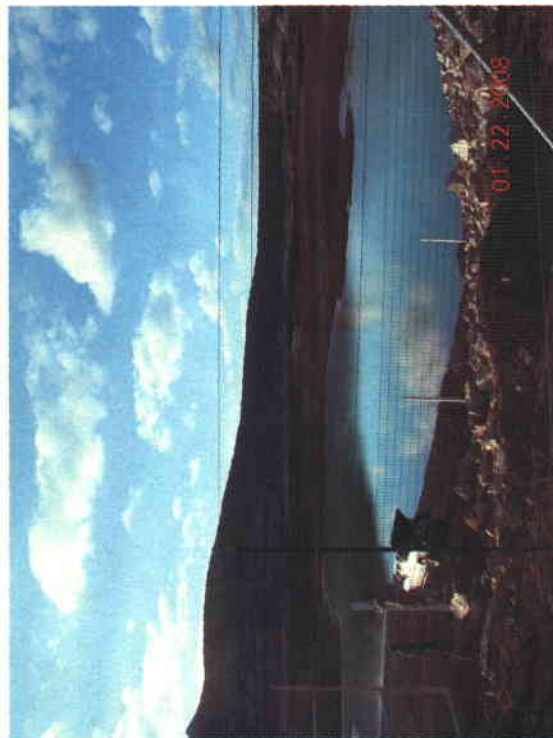
The evaporation pond has been completed except for finishing the fencing. The operator is pumping water from the mine into the pond.

Photo 4. The evaporation pond.
